# Property Inspection Report

123 Main Street, Destin, FL 32541

11/22/2020

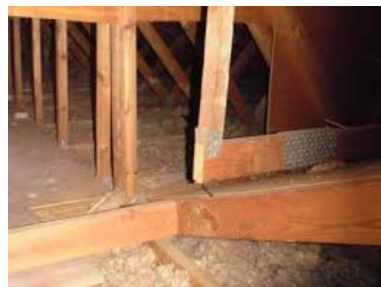
- **Repair:** Truss members should not be cut, notched, drilled, spliced or otherwise altered in any way without the approval of a registered design professional. This condition should be evaluated by a qualified engineer.

- **Repair:** Truss members should not be cut, notched, drilled, spliced or otherwise altered in any way without the approval of a registered design professional. This condition should be evaluated by a qualified engineer.

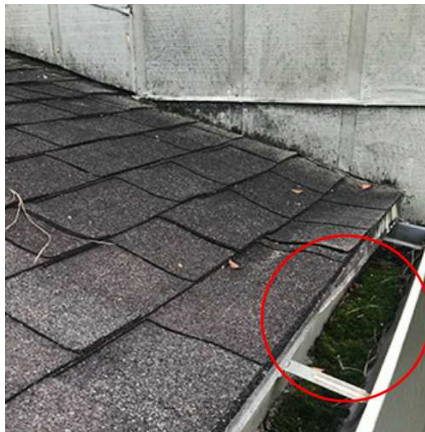
- **Repair:** The gutters require cleaning to avoid spilling roof runoff around the building a potential source of water entry or water damage.

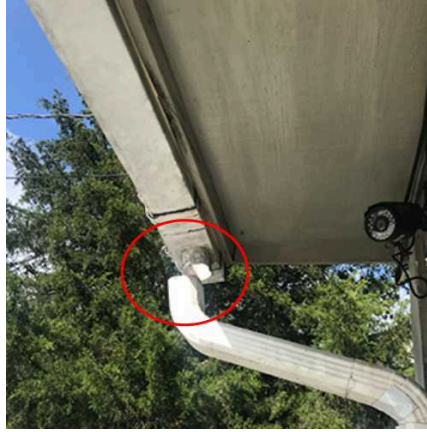
- **Repair:** Loose or damaged downspouts should be repaired promptly.

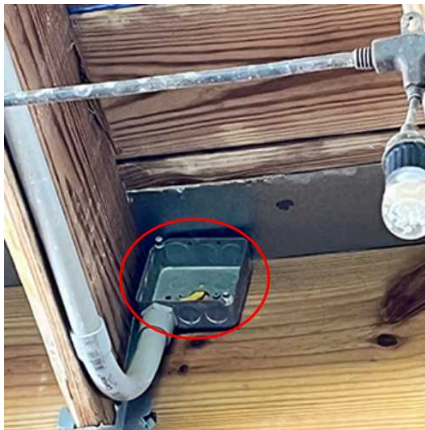
- **Repair:** All open junction boxes as noted under deck should be fitted with cover plates in order to protect the wiring and reduce the risk of potential fires that may be caused by poor connections.

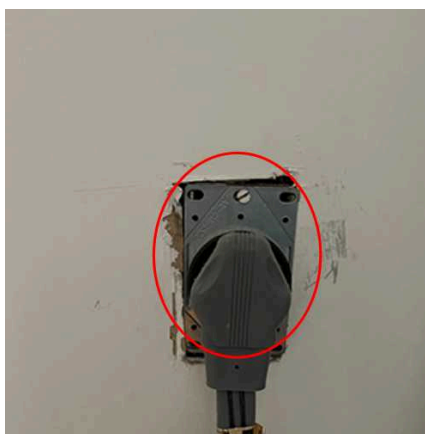
- **Repair:** Any missing outlet covers should be replaced for improved safety.

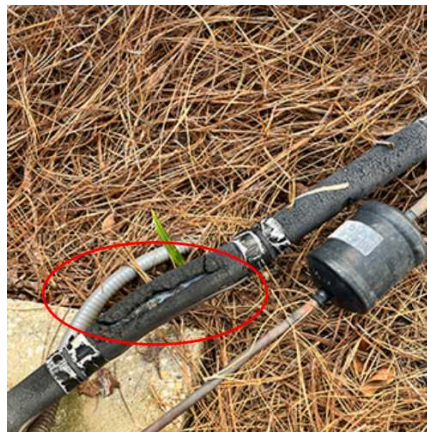
- **Repair:** Damaged and or missing insulation on refrigerant lines should be repaired. These outside lines should be insulated all the way to the compressor unit to prevent loss of temperature in the lines.

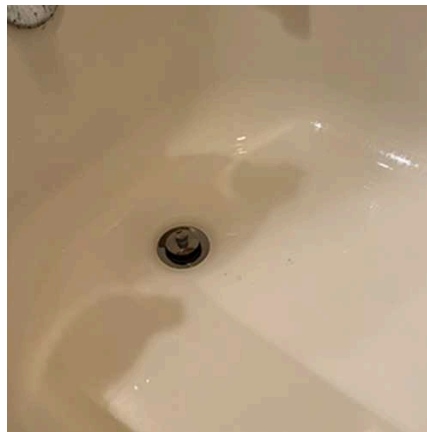
- **Repair:** The bathtub was observed to drain slowly, suggesting that an obstruction may exist. Recommend the tub be snaked to remove any blockages.

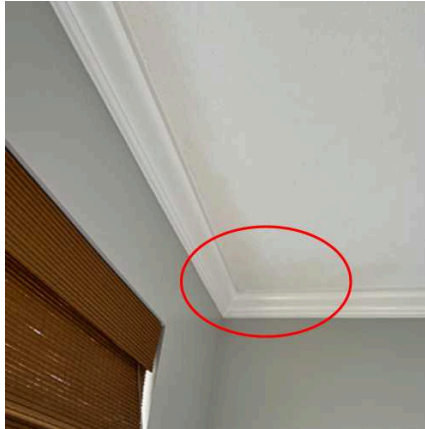
- **Repair:** An apparent water staining was noted in the ceiling master bedroom. The area was dry at the time of the inspection, but leakage could not be definitively ruled out based on a one time visit to the home. Recommend consulting with the current owners for additional information prior to closing. If the leak is still active, recommend repair/replace as needed to remedy the leak.

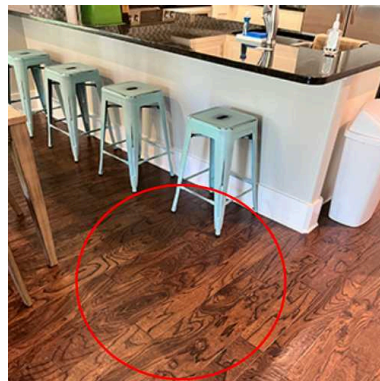
- **Improve:** Minor creaking was observed in the floor structure in the living room in front of the island. This condition is fairly common. It may be the result of the materials, framing design, installation methods and aging of the home. Better securing of the subflooring to the joists normally will improve this condition.
