# Property Inspection Report

123 Main Street, Destin, FL 32541

11/22/2020

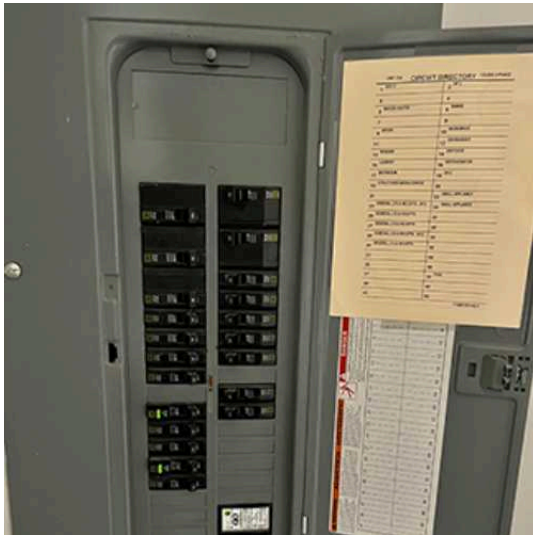
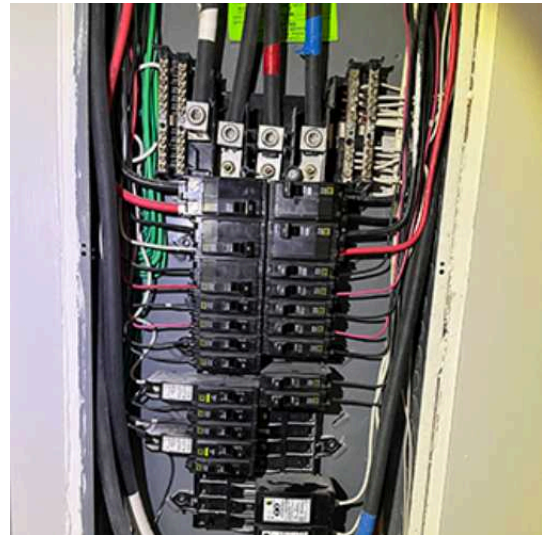
The size of the service ( amps) appears to be sufficient for typical electrical requirements of a home this size. Inspection of the electrical system did reveal the need for typical, minor repairs. A licensed electrician should be consulted to undertake the repairs recommended below and to evaluate the entire system for further repairs that may be needed.

- **Repair:** All open junction boxes as noted under deck should be fitted with cover plates in order to protect the wiring and reduce the risk of potential fires that may be caused by poor connections.

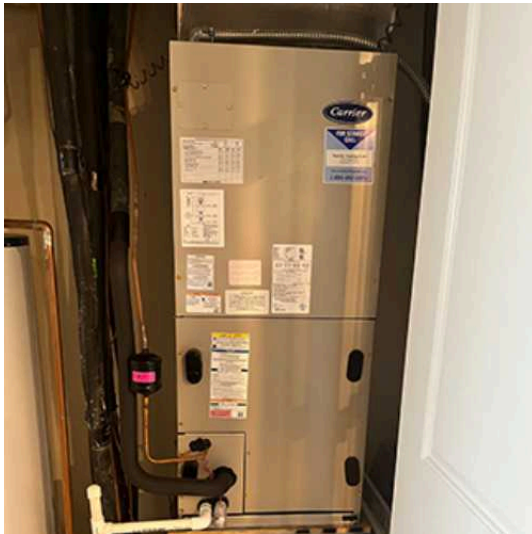
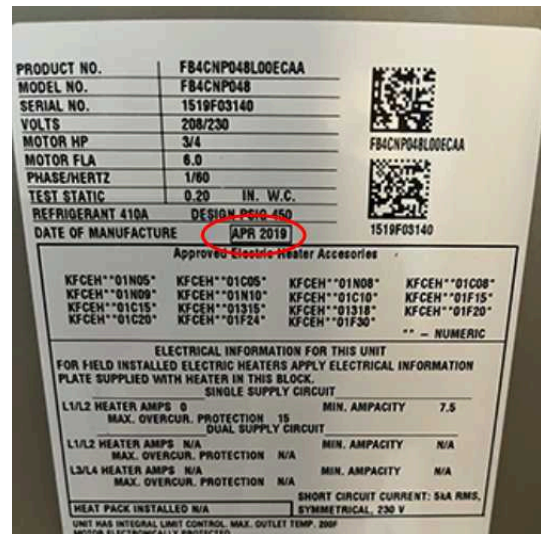
2019

The furnace appears to be approximately 2 years old based on the serial number. The typical life for such a unit is 20-25 years based upon proper maintenance scheduling. The furnace responded to normal operating controls at the time of inspection. Adequate heating capacity is provided by the system and heat distribution within the home is adequate.

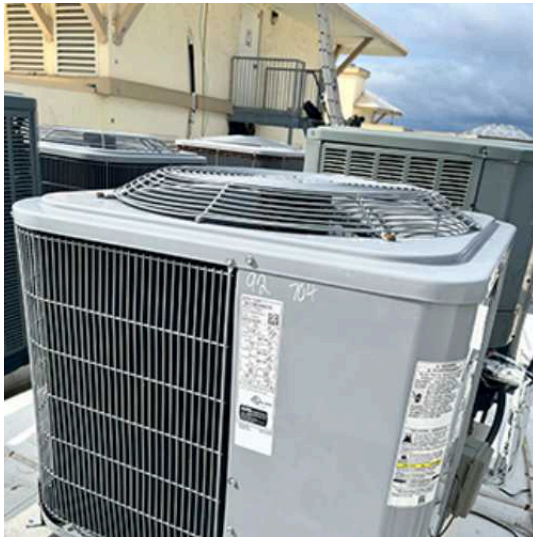
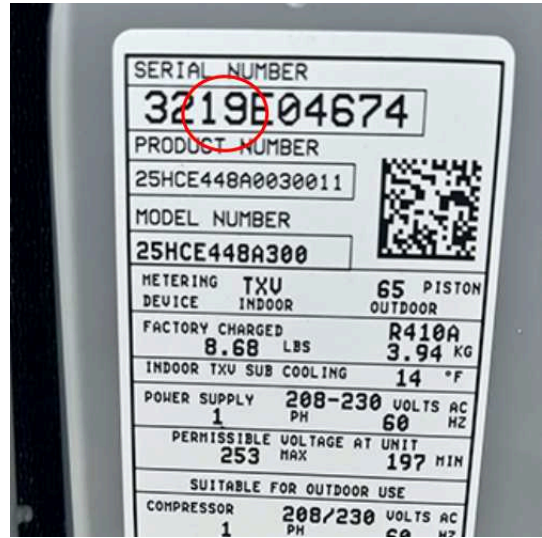
2019

The outdoor unit appears to be approximately 2 years old based on the serial number. The typical life for such components is 12-15 years based on proper maintenance scheduling. Upon testing in the air conditioning mode, a normal temperature drop of between 15 to 20 degrees across the evaporator coil was observed. This suggests that the system is functioning properly. The capacity and configuration of the system should be sufficient for the home.

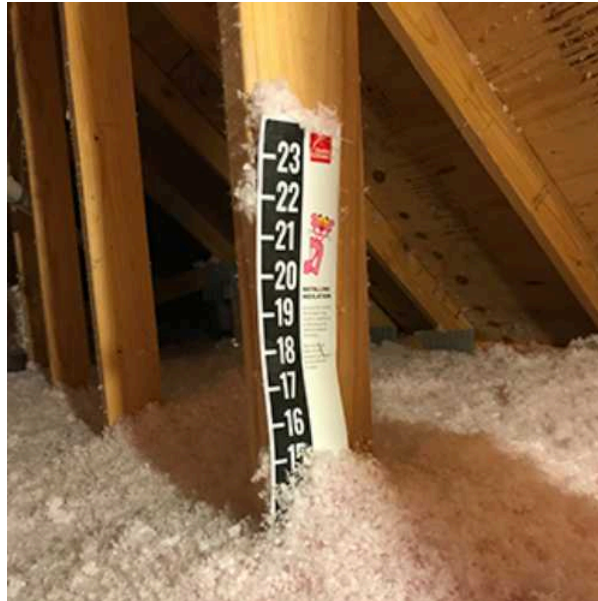
Overall, this is a well insulated home. Any further insulation improvements will help to reduce utility costs.

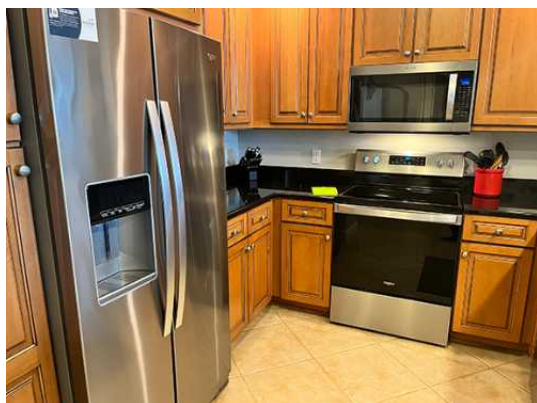
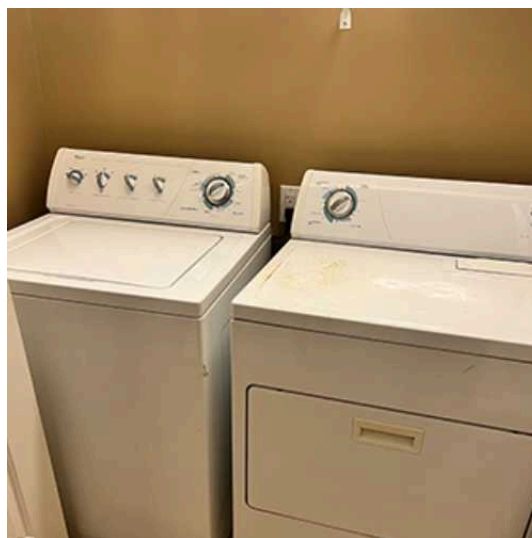
All tested appliances were in good working order.
